## NOTA INFORMATIVA DE ACIDENTE COM AERONAVE AIRCRAFT ACCIDENT INFORMATION NOTICE

| PROCESSO GPIAAF GPIAAF PROCESS ID<br><br>2024/ACCID/05 | | Classificação Classification<br>Acidente Accident | |
| Tipo Type<br>Leonardo AW139 | | N.º de série Serial No.<br>31034 | Matrícula Registration<br>EC-JOU |

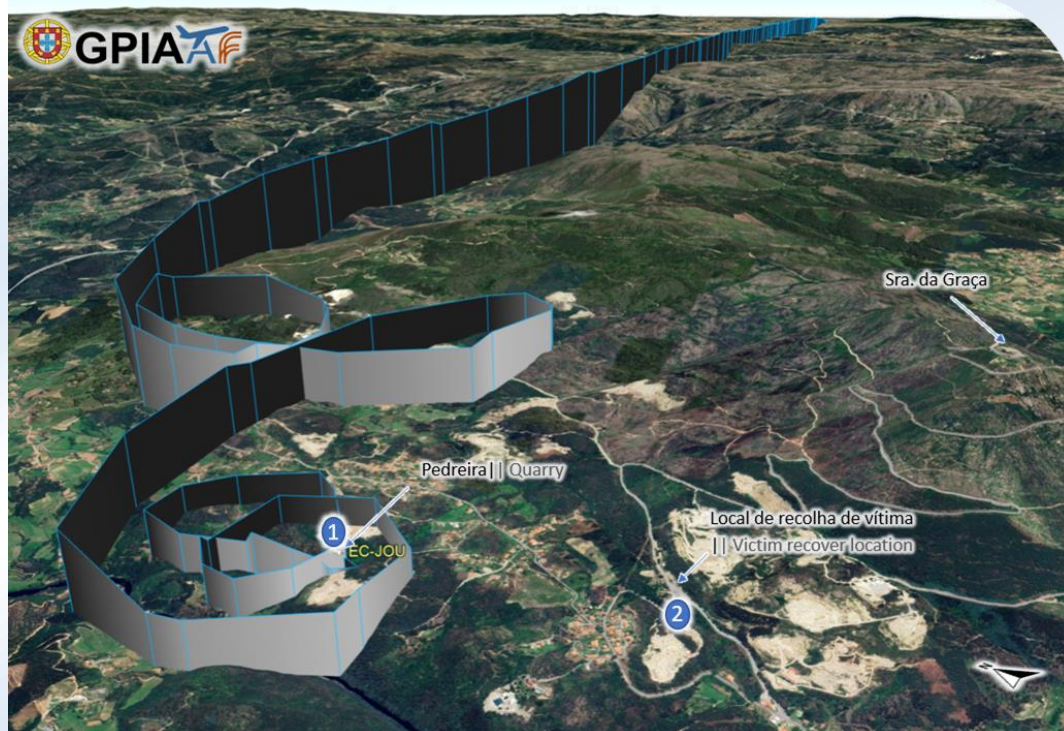
**Figura 1** || **Figure 1**  
Trajeto da missão || Mission flight path

As equipas de socorro dos bombeiros locais e GNR localizados na pedreira, prepararam a vítima para o transporte, tendo identificado um local de aterragem num largo próximo (detalhe 2 na figura), a cerca de 1,3 km de distância, a sul da pedreira, para onde a vítima seria transportada de ambulância para posteriormente seguir de helicóptero.

Durante o voo, os pilotos receberam atualização das coordenadas do referido local, inseriram os dados no sistema de navegação e voaram direto para o local. Após dificuldades iniciais na localização das equipas de apoio à vítima, o helicóptero realizou várias voltas até os ocupantes terem identificado um veículo de emergência na pedreira, identificando de seguida um possível local para a aterragem (detalhe 1 da figura).

First-responders from the local fire service and GNR officers had already arrived at the quarry and were preparing the victim for transportation, having identified a landing spot (detail 2 in figure), for the helicopter, in a nearby square, about a 1,3 km away, South of the quarry, where the victim would be taken by ambulance to meet the helicopter.

During the flight, the pilots received an update of the site coordinates, uploaded them in the aircraft's navigation system and headed for the site. After initial difficulties in locating the victim support teams, the helicopter made several turns until the occupants identified an emergency vehicle in the quarry, then identified a possible landing site (detail 1 of the figure).

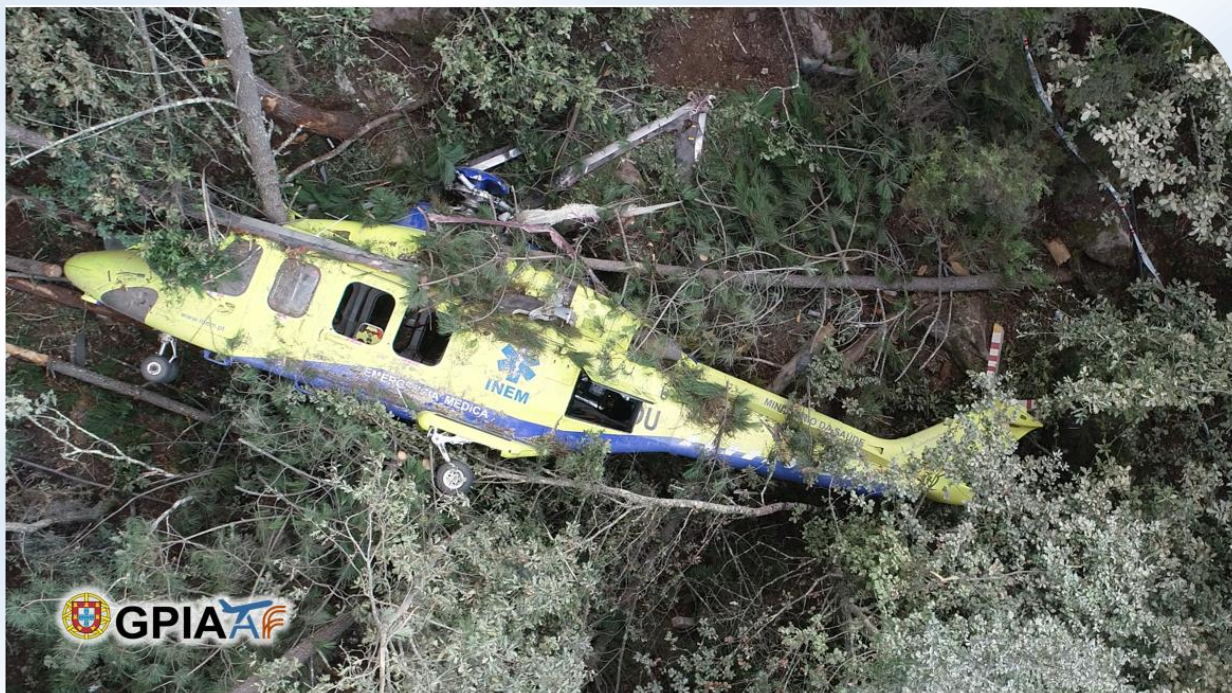
**Figura 2** ||

Em sequência, a aeronave colidiu com várias árvores de médio e grande porte, danificando o rotor principal e inviabilizando a descolagem.

A aeronave imobilizou-se na base dos pinheiros sobre o seu lado direito mantendo a integridade da cabine com a zona direita do cockpit a ser perfurada por um pinheiro de grande porte.

Subsequently, the aircraft collided with several medium and large trees, damaging the main rotor which made the take-off attempt unfeasible.

The aircraft came to rest at the base of the pine trees on its right side maintaining the integrity of the cabin with the right cockpit area being penetrated by a large pine tree.

Posição final da aeronave ||

Aircraft final position
